# WRIA 26, LOWER COWLITZ WATERSHED RIPARIAN CONDITIONS

MAP - 11a

# WRIA 26, UPPER COWLITZ WATERSHED

## RIPARIAN CONDITIONS MAP - 11b

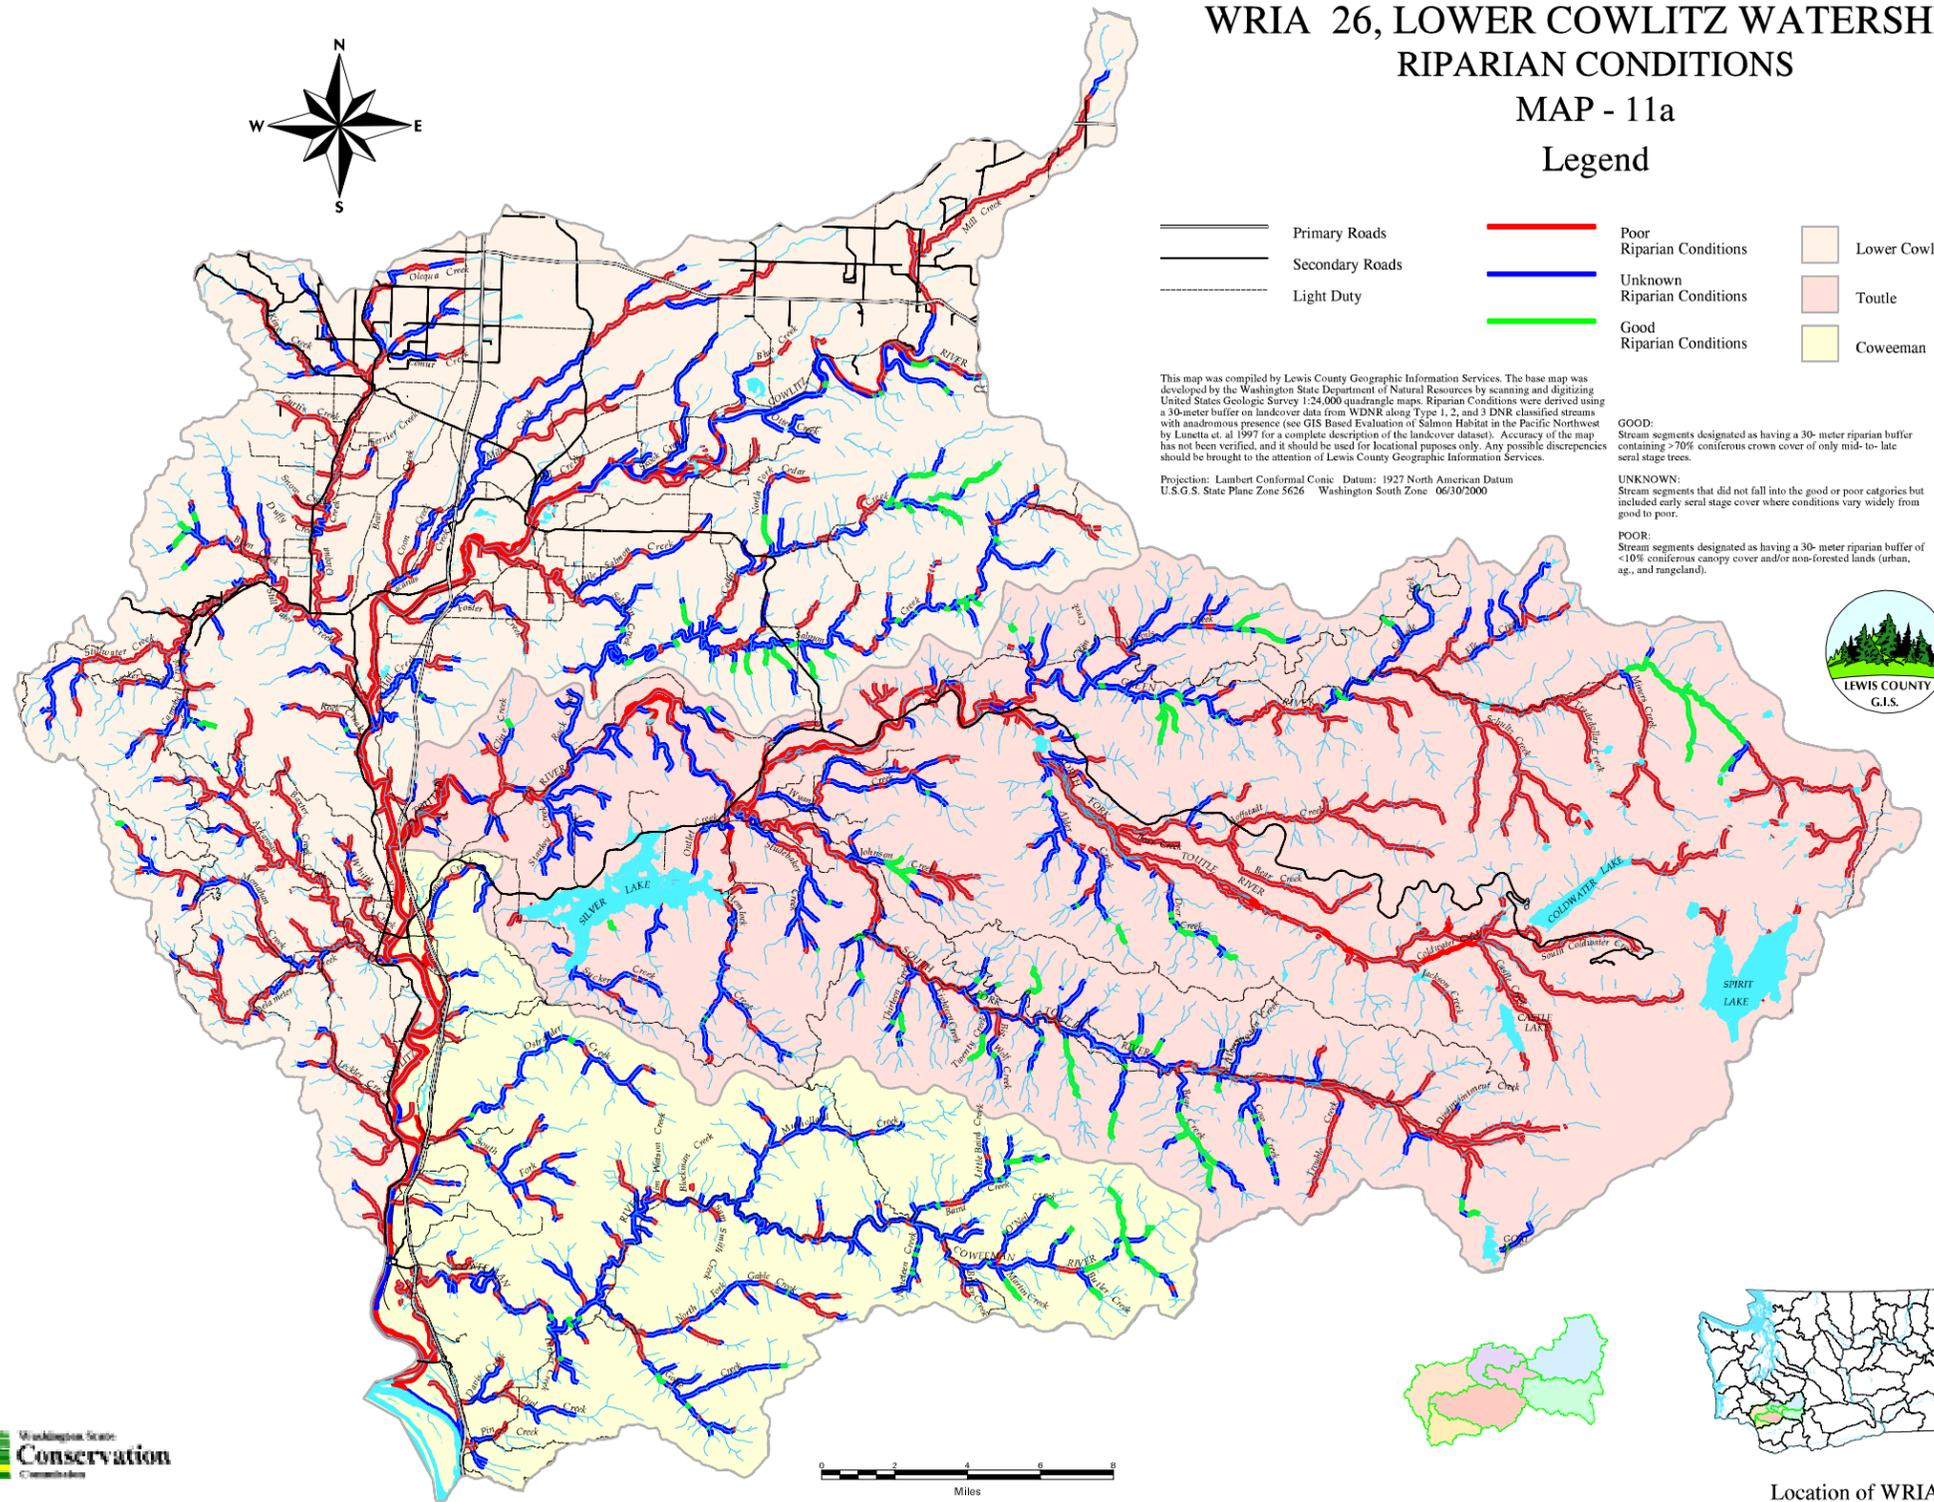
This map was compiled by Lewis County Geographic Information Services. The base map was developed by the Washington State Department of Natural Resources by scanning and digitizing United States Geologic Survey 1:24,000 quadrangle maps. Riparian Conditions were derived using a 30-meter buffer on landcover data from WDNK along Type 1, 2, and 3 DNR classified streams with anomalous presence (see GIS Based Evaluation of Salmon Habitat in the Pacific Northwest by Lunetta et. al 1997 for a complete description of the landcover dataset). Accuracy of the map has not been verified, and it should be used for locational purposes only. Any possible discrepancies should be brought to the attention of Lewis County Geographic Information Services.

**GOOD:**  
Stream segments designated as having a 30-meter riparian buffer containing >70% coniferous crown cover of only mid-to-late seral stage trees.

**UNKNOWN:**  
Stream segments that did not fall into the good or poor categories but included early seral stage cover where conditions vary widely from good to poor.

**POOR:**  
Stream segments designated as having a 30-meter riparian buffer of <10% coniferous canopy cover and/or non-forested lands (urban, ag., and rangeland).

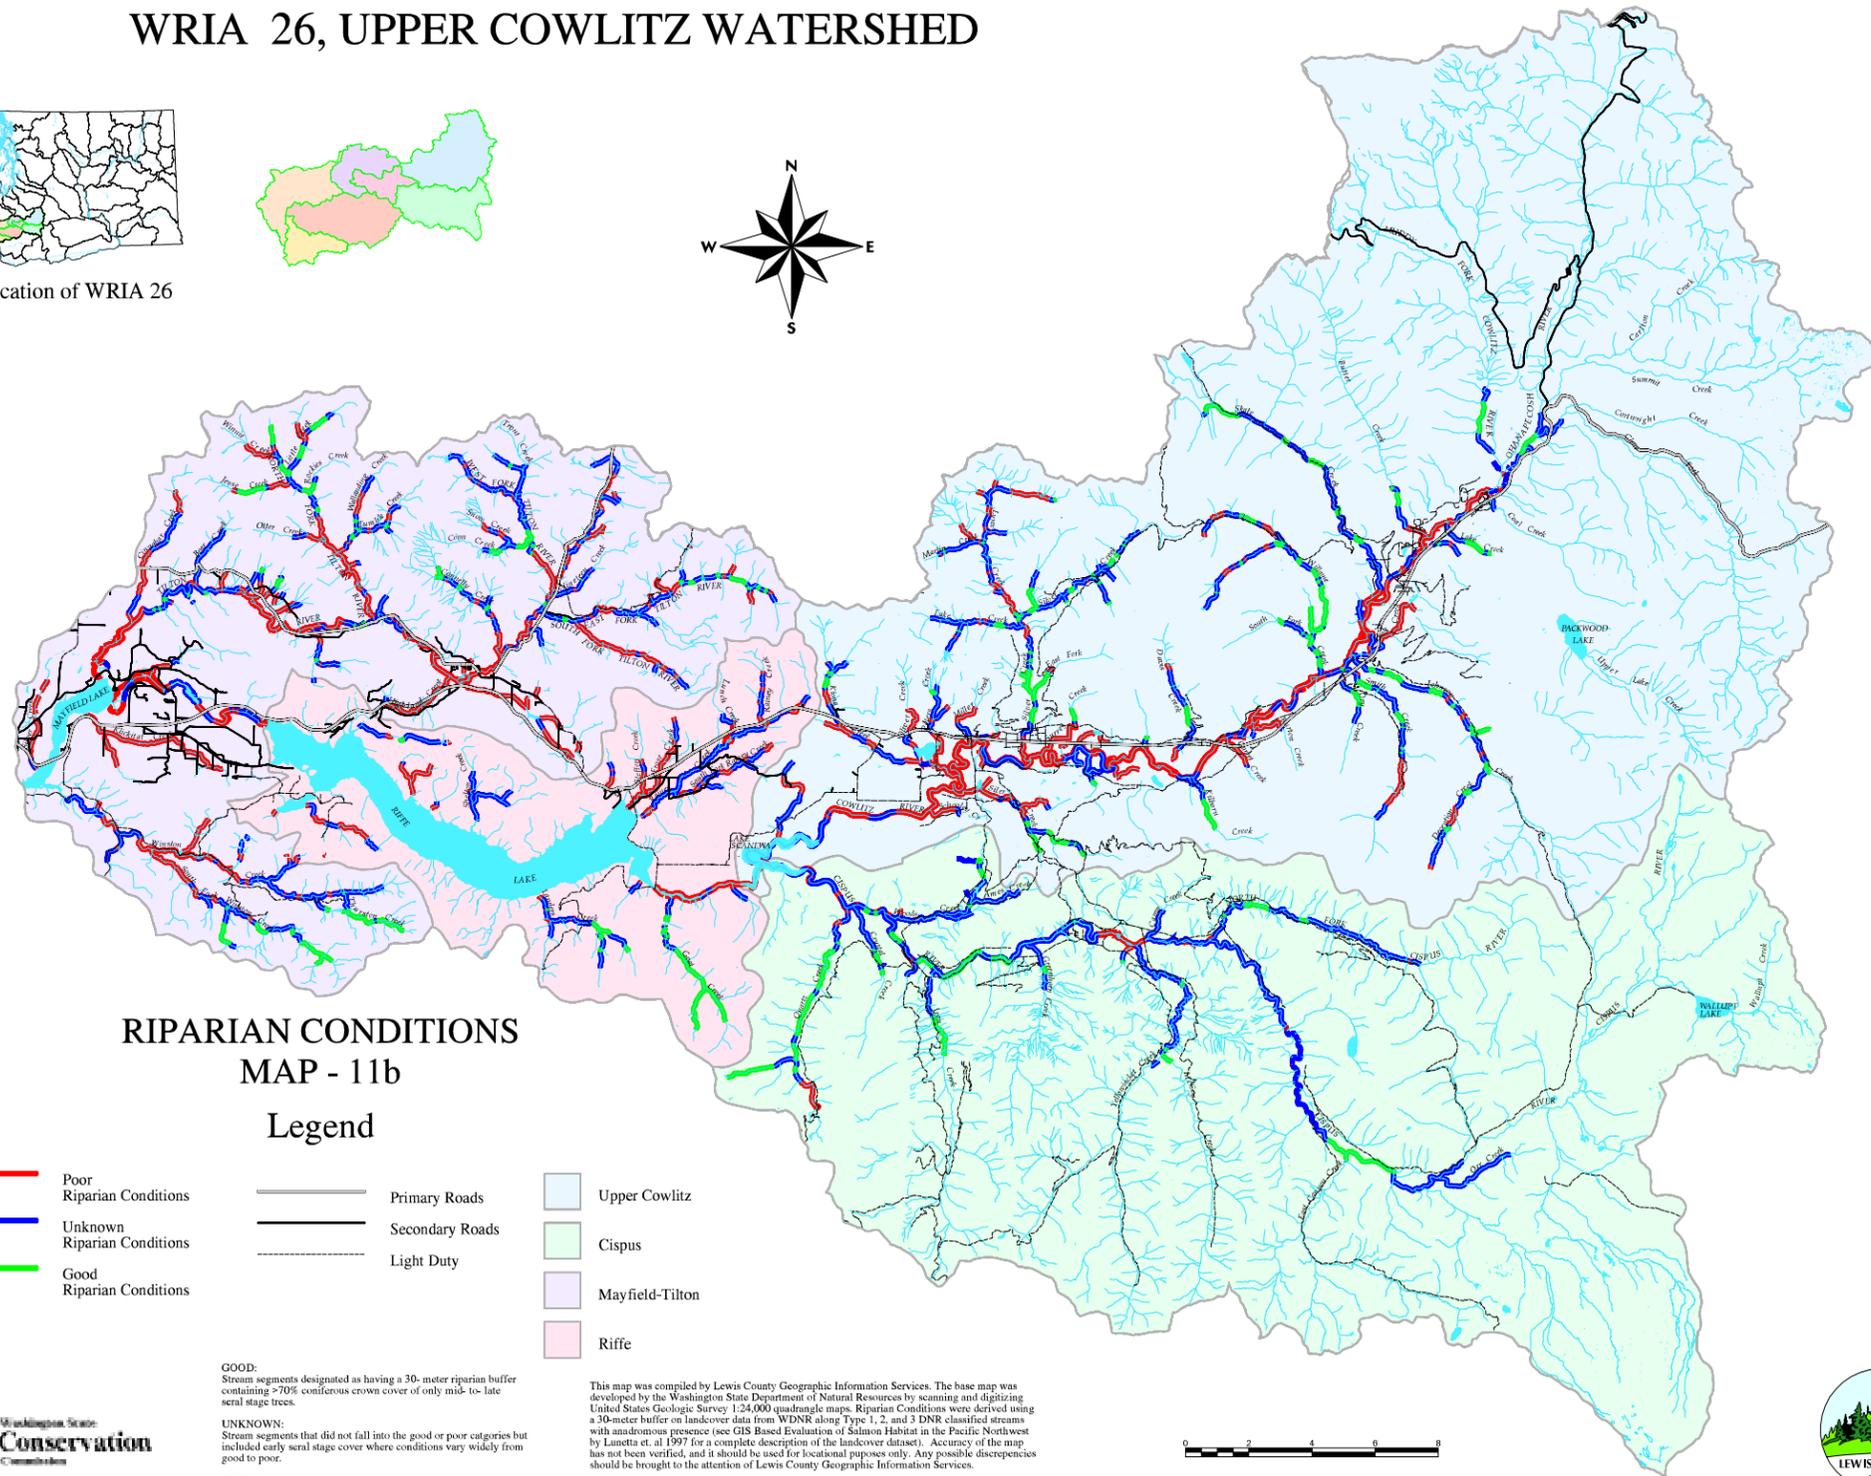
**GOOD:**  
Stream segments designated as having a 30-meter riparian buffer containing >70% coniferous crown cover of only mid- to late seral stage trees.

**UNKNOWN:**  
Stream segments that did not fall into the good or poor categories but included early seral stage cover where conditions vary widely from good to poor.

**POOR:**  
Stream segments designated as having a 30-meter riparian buffer of <10% coniferous canopy cover and/or non-forested lands (urban, ag., and rangeland).

This map was compiled by Lewis County Geographic Information Services. The base map was developed by the Washington State Department of Natural Resources by scanning and digitizing United States Geologic Survey 1:24,000 quadrangle maps. Riparian Conditions were derived using a 30-meter buffer on landcover data from WDN along Type 1, 2, and 3 DNR classified streams with anadromous presence (see GIS Based Evaluation of Salmon Habitat in the Pacific Northwest by Lunetta et. al 1997 for a complete description of the landcover dataset). Accuracy of the map has not been verified, and it should be used for locational purposes only. Any possible discrepancies should be brought to the attention of Lewis County Geographic Information Services.
