Ferry Conservation District

2018 FEATURE ACCOMPLISHMENT

Kettle River Riparian Stabilization

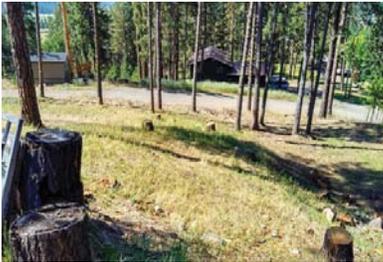
This Firewise project on the edge of Republic helps to protect this neighborhood from wildfire.

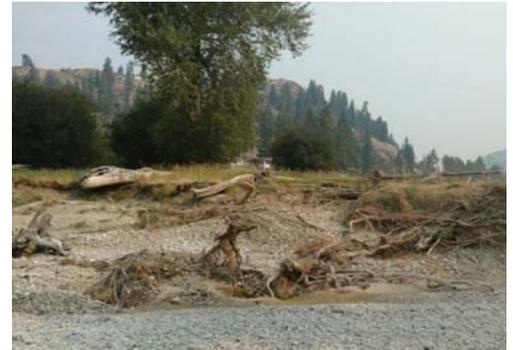
Over the past 75+ years, the riparian area along this reach of the Kettle River has suffered serious degradation. Crumbling high banks contribute to increased sediment loads. The river banks are stripped of vegetation. This contributes to high water temperatures. A poorly defined stream channel made the property prone to spring flooding. The landowners requested our assistance, and, using funds from a Washington Department of Ecology water quality grant, Ferry Conservation District (FCD) stepped in to help restore the riparian buffer.

The steep, highly-erodible bank prior to construction.

We convened our area management team to brainstorm the project area's needs. Then we hired an engineering firm to design a project that could stabilize the river bank, reestablish the riparian buffer, and still allow the landowners' access for recreation. We installed large woody debris to diffuse the force of the river's current. The bank was re-sloped to a more gentle, less erodible 3/1 pitch. The biggest challenge was reestablishing the riparian buffer.

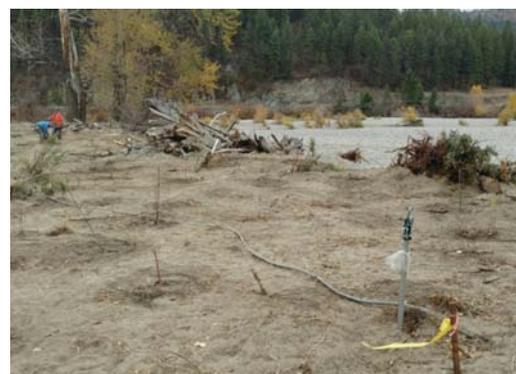
Final stages of the project. Banks are stabilized, woody debris is placed, and buffer is planted.
